# System 800xA

Release Notes

Resolved Issues

System Version 6.0.2

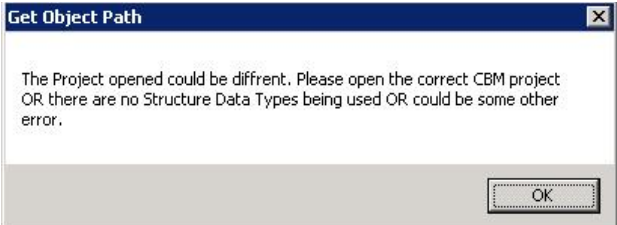
Issue	Correction or Fix
<p>In some cases, after clicking Upload in the SFC Uploader aspect window, the following error message appeared even though the correct project was opened in Control Builder.</p>

<p>800xASFC-OL-5110-001</p>	<p>This problem has been corrected.</p>

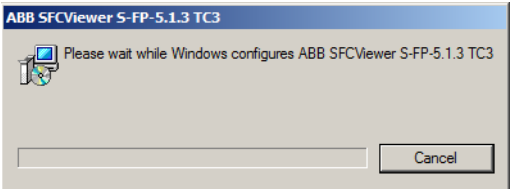
Issue	Correction or Fix
<p>On accessing the SFC Viewer Uploader aspect and Viewer aspect of a library Control Module Type element, in Object Type Structure, the workplace stops responding.</p> <p>800xASFC-OL-5130-007</p>	<p>This problem has been corrected.</p>
<p>SFC upload at the application level might not fetch variables for Structure Data Type of a child SFC, and the object navigation fails.</p> <p>800xASFC-OL-5130-008</p>	<p>This problem has been corrected.</p>
<p>Following software configuration message is displayed for first time, if a graphic display is accessed from any user account other than installed user account:</p>

<p>800xASFC-OL-5130-009</p>	<p>This problem has been corrected.</p>
<p>Communication Variables used in Single Control Module are not listed as part of SFC Viewer Uploader, and they are also not listed in SFC Viewer transition for navigation.</p> <p>800xASFC-OL-5130-010</p>	<p>This problem has been corrected.</p>
