Case Study PCS80 Active Voltage Conditioner

ABB voltage conditioner helps the mail go through

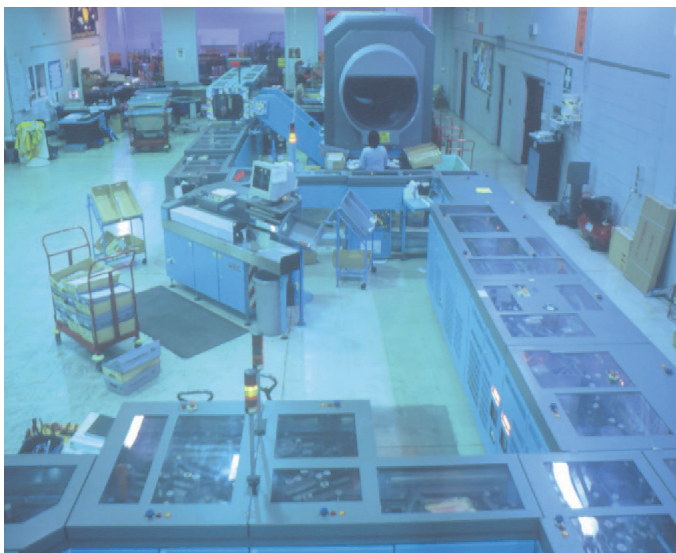
NSMC Mail Sorting Machine

At 33 metres long, the mail sorting machine occupies a very large floor space. Letter mail is deposited into a large rotating section at one end, inevitably dubbed the "concrete mixer," from where it tumbles into the start of the sorting process.

Reversible belts take care of reversed or inverted envelopes, and each address is scanned and its information collected into a 12-digit machine directory code which is applied to the envelope as a bar code. In this way each piece of mail is tracked at each stage through the machine, either to one of the reject bins or sorted into final destinations.

A metal detector ejects those envelopes containing staples, paper clips and coins, while other criteria such as illegibility, inflexibility or size over 200mm high or 6mm thick are also cause for rejection. Rejected mail is hand sorted, but Peter says the majority of handwritten addresses can be read by the machine.

Over 33,000 items of mail go through the sorter every hour, close to the maximum rate of 37,000, and all moving at a rate of 3 metres/second or 10.8 kilometres/hour. Automatic cutouts, with their operation marked by flashing lights, are located at numerous points, and any blockage or raising of cabinet covers will bring the entire operation to a temporary halt.
