# NOVEL APPROACH to ARC FLASH MITIGATION for LOW VOLTAGE EQUIPMENT

ESW2016-07

**Abstract** - As industry pursues safer workplaces with arc flash mitigation programs, they face major challenges in effectively reducing incident energies on the secondary of medium voltage to low voltage (MV-LV) transformers. When an arc fault occurs on the transformer secondary, primary currents can be below the short circuit range of the primary protection. Typical E-rated fuses can take over 2 seconds to clear while high side device 51 relays will have a waiting period before initiating a breaker trip. Solutions that adjust the LV main breaker's (if applied) protective functions for faster response, do not address arc fault issues on the bus connecting this main breaker to the transformer secondary. This paper presents a method of applying a high speed grounding switch (HSGS) at a location between the MV E-rated fuse load terminal and the transformer's primary connection. Since the transformer's primary voltage is reduced to zero in milliseconds, the low voltage arc flash event collapses quickly to limit incident energies to less than 1.2 cal/cm<sup>2</sup>. Applications can include MV-LV transfor

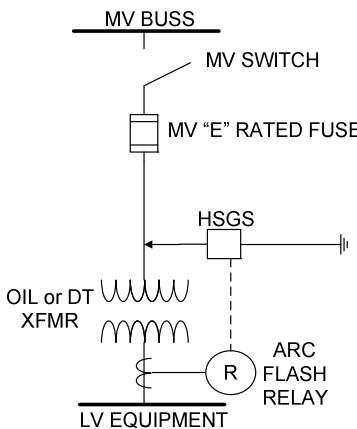
A more effective application with minimal impact on transformers is to apply the HSGS downstream of a CL fuse. Since the fuses will fully interrupt in less than ½ cycle, the sourcing transformer will never be exposed to the fault waveform peak. Applying light detection relays at the LV equipment and tripping the HSGS at the MV level solves the LV arc flash in two simple steps. See Fig. 1.

Fig. 1 Typical Industrial/Commercial Facility

1. Upon sensing of an arcing fault, the relay signals the HSGS to close. When the resultant solid three-phase bolted ground fault collapses the transformer primary voltage to 0V, the LV arc flash extinguishes in milliseconds. The arc flash detection and HSGS closing is accomplished in approximately 4ms.
2. The three-phase bolted ground fault brings the MV system to zero volts. The time duration of this voltage dip is determined by CL fuse interruption time which will be very fast with the entire MV short circuit current (SCC) flowing through the fuse. The larger the SCC magnitude, the shorter the voltage dip duration. The CL fuse becomes a voltage dip duration device. This step is discussed further in the following sections.

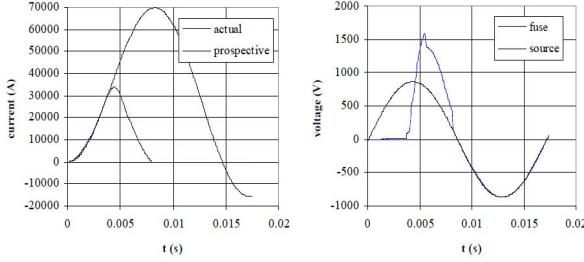
Fig. 3 shows the waveforms from single phase operation of a fuse interrupting a short circuit fault current in an AC circuit. Operation of the fuse can be considered to be two distinct parts: the pre-arching (melting) period and the arcing period.

Fig. 3. Current Limiting Operation Waveforms

*Pre-arching period.* At the initiation of a fault current, the fuse element will begin to heat up, and resistance will increase very slightly. Consequently the fault current will be very close to the prospective fault current since the voltage drop across the fuse will still be low. Note that the system voltage at the line side of the fuse is near 0 V during the 4ms pre-arching period shown in the figure. Since current limiting fuses must melt before the first fault current peak is reached, factors such as the melting  $i^2t$  of the fuse, available fault current, fault initiation angle and source X/R ratio can affect the duration of this period. For example, higher fault currents typically result in shorter pre-arching periods.

*Arching period.* When the fuse element melts, arcing begins in the notches of the element. At this time the fuse resistance and voltage will increase rapidly. When the voltage developed across the arc resistance reaches the instantaneous system voltage the current starts to decrease. Referring to Fig. 4, the negative  $di/dt$  results in a voltage rise across the line reactance that supports the system voltage. This voltage,  $V_x$ , is present until the current is forced to a current zero. Current limiting fuses will melt and clear these short circuits in less than 1/2 cycle. The magnitude of the system overvoltage created by the fuse is dependent upon system parameters and by the rate at which the arc resistance increases. If the resistance rises too fast, a large  $di/dt$  could cause too large of a system overvoltage.

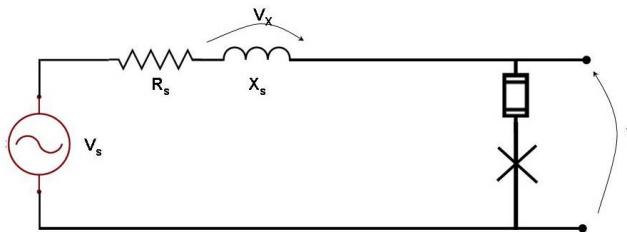
Fig. 4. Circuit showing source of transient arc voltage

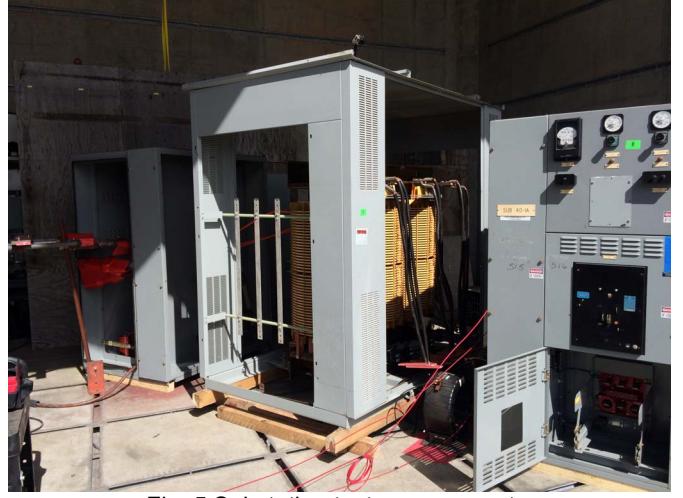
Tests were performed in a high power test lab to quantify the reduction of LV energy possible with the HSGS with typical LV non arc-resistant switchgear. The equipment tested, shown in the photo of Fig. 5 and the diagram of Fig. 6, was placed into the arc resistant test cell of the test lab.

Fig. 5 Substation test arrangement.

Test 9 was performed in the feeder circuit breaker compartment (The bottom compartment in Fig. 5). The breaker was removed and a #18 shorting wire was connected between the line side stabs (Fig. 8). Since the instantaneous trip on the secondary main breaker was disabled the primary fuse was the circuit protection for the LV fault. However, anticipating a clearing time of greater than 5 seconds for the primary fuse, the station breaker was set at 500ms.

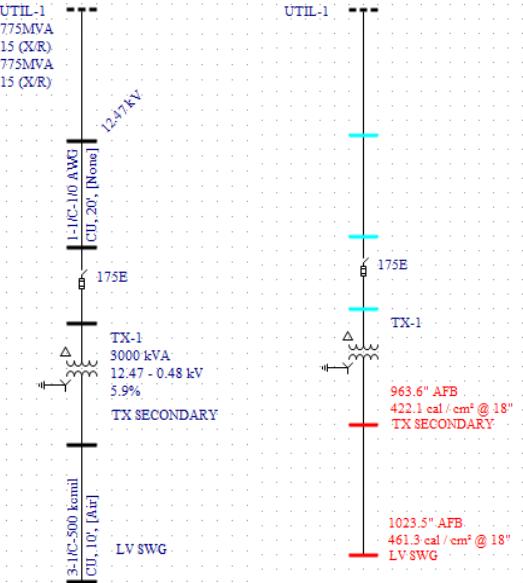
Fig. 6. Calculations Model of Incident Energy and  $I_{arc}$ .

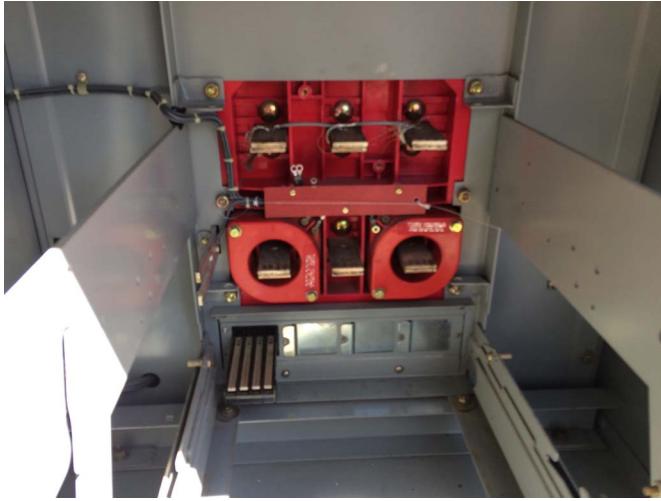
Fig. 8 Trigger wire on line side stabs in feeder breaker compartment.

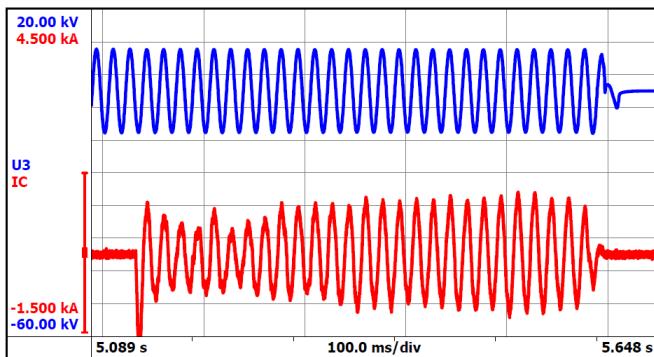
The traces in Fig. 9 show the characteristics of the arc event. The event begins when the trigger wire melts and current starts to flow through the arc. The arc current varies throughout the fault but sustains for the full duration of the test when the fault is cleared by the station breaker. During this test the MV fuse never opened.

Fig. 9. C phase current (B) and voltage (T) from Test 9.

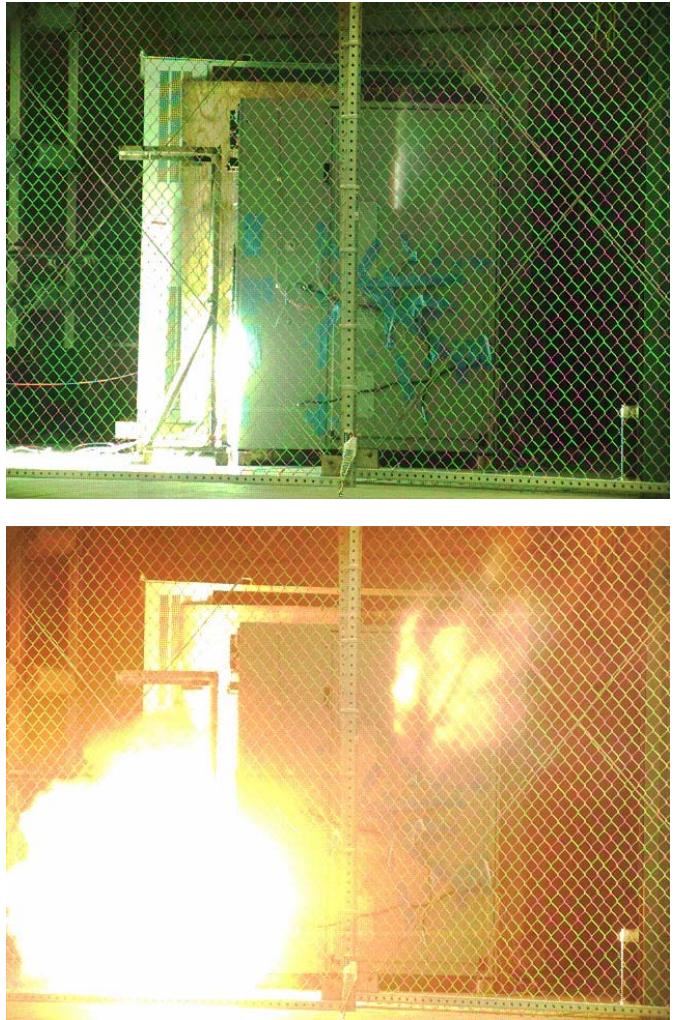
The photos of Fig. 10 were taken from the high speed video of the test and shows that faults initiated in this manner would generate outward plasma flows in a manner similar to the test box using the horizontal electrode configuration in the research performed for [5]. This configuration is considered to be the worst case configuration for incident energy measurements near the opening of the enclosure.

Fig. 10. Photos of test at 1ms and 302ms.

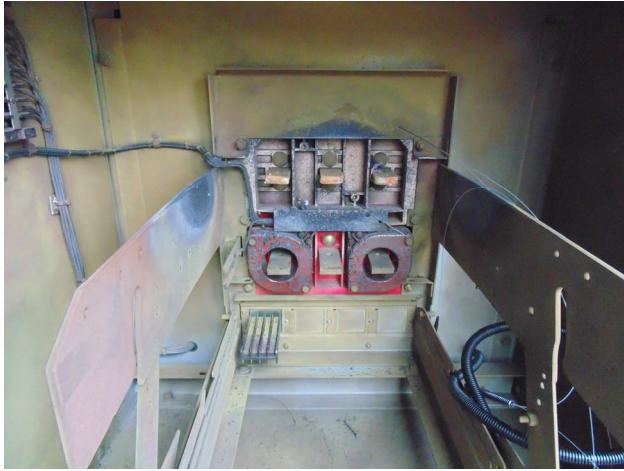
The photo in Fig. 11 shows extensive damage to the feeder compartment under test. It appears that copper oxides have coated all the components within the compartment. Copper oxides were also present throughout the LV bus structure due to the expansion of the plasma ball during the duration of the test. See bottom photo of Fig. 10.

Fig. 11 – Damage to compartment from Test 9

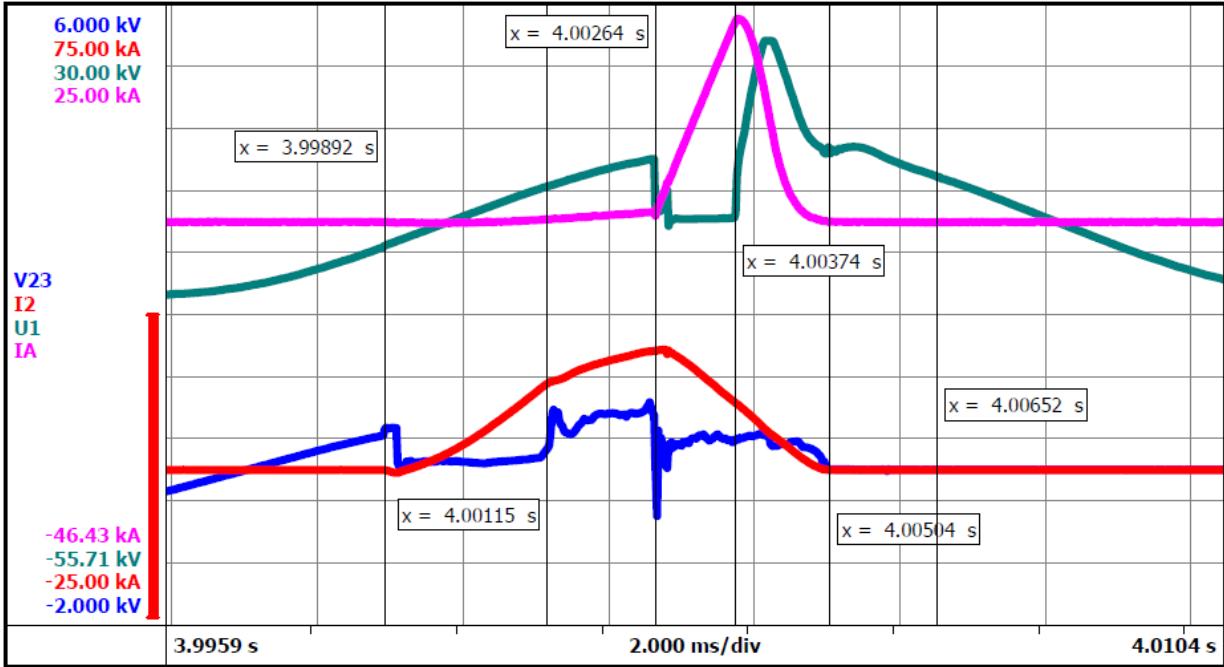
The traces in Fig. 12 show the performance of the protection system. Refer first to the low voltage traces at the bottom of the figure. The event begins when the station making switch is closed and current starts to flow through the trigger wire. The voltage is near 0V until the trigger wire melts in about 2.2ms. At that time, current starts to flow through the arc and an irregular shaped arc voltage appears. The arc current continues to rise towards an instantaneous value expected to be greater than 30kA. Approximately 1.5ms later the HSGS closes. This can be seen in primary voltage waveforms at the top of the figure where the trace drops rapidly to near 0V. The primary current, expected to be near  $860\text{A}_{\text{rms}}$  for the secondary arc fault, now begins to rise toward the expected instantaneous value of near 104kA for a bolted fault current on the primary side. However the primary fuse melts 1ms later when the instantaneous current reaches 23.4kA in phase A. The voltage across the fuse now begins to rise. Due to the  $\text{d}/\text{dt}$  at melting the voltage developed across the source inductance is added to the source voltage. The resulting peak value of 25.0kV is well below the limits of IEEE C37.46 [7]. The fuses have fully cleared the circuit 2.8 ms after melting.

Fig. 12. Test 5 waveforms showing operation of system. The low voltage traces are on the bottom.

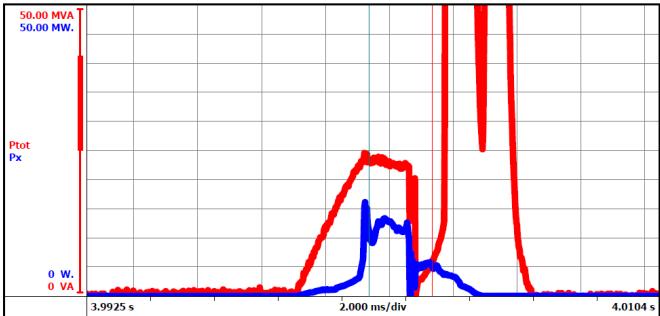
Fig. 13 shows the waveforms of the power calculated from the current and voltage data.  $P_{\text{tot}}$  is the calculation of MVA with primary (MV) quantities.  $P_x$  is the power calculated from measured LV quantities (assumed to be watts delivered to arc). The low voltage power trace in blue shows that for near 2 ms after the HSGS closed, arc energy was transferred into the arc at a reduced power level. It is the authors' belief that the additional power transfer is from energy stored in the circuit. The large rise in primary power (red trace) after HSGS

closure is mostly the arc energy within the primary fuses. The calculated  $W_{\text{arc}}$  of 27.6kWs resulted in a maximum incident energy measurement of  $0.4 \text{ cal/cm}^2$ . The measured values of  $W_{\text{arc}}$ ,  $P_{\text{arc}}$  and Incident Energy are recorded in Table 1.

Fig. 13. Power measurements from Test 5

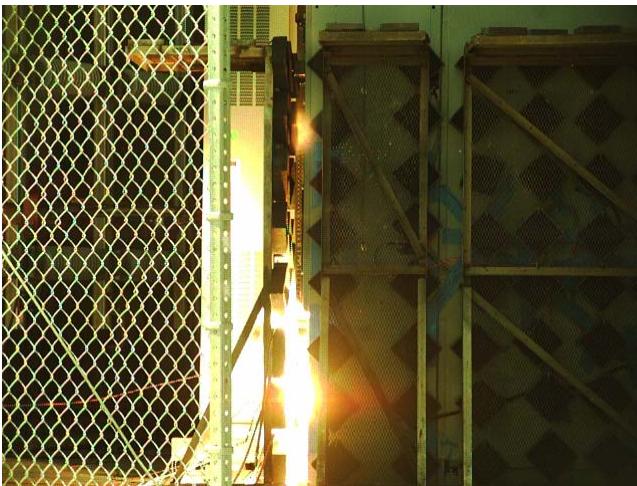
Frames from the high speed video were reviewed. The photo in Fig. 14 shows the farthest reach of the (glowing) hot gases generated from the arc. As evidenced from the photo of Fig. 15, minimal damage was sustained by the equipment.

Fig. 14. Photo at 4.2ms from high speed video of Test 5

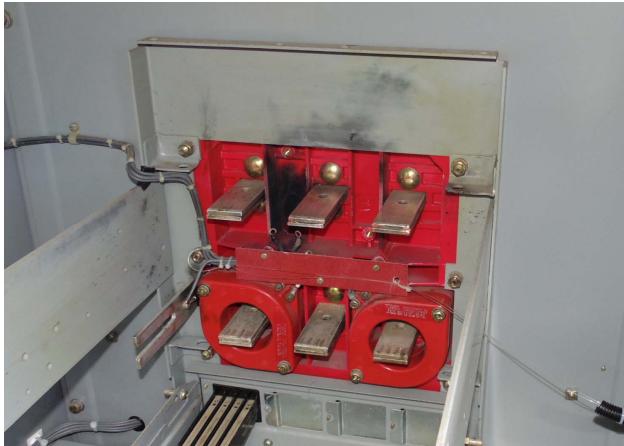
Fig. 15. Photo of damage to feeder compartment after arc fault with HSGS protection.

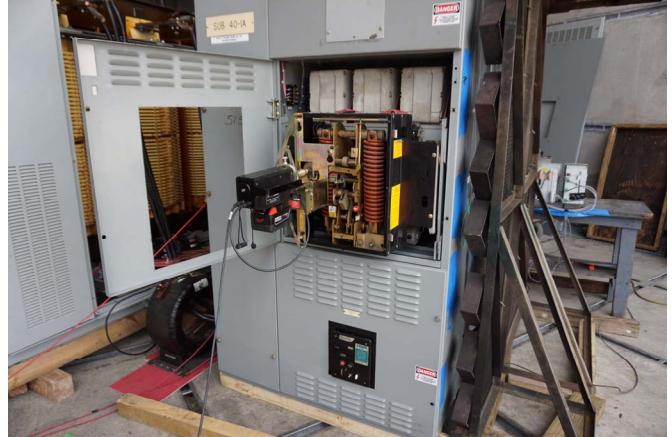
In Test 7, performance of the HSGS was evaluated for a simulated arc fault due to a racking failure. The same electrical circuit was used as in test 5. The LV main circuit breaker was racked out and a trigger wire was connected between the line side breaker stabs. Using a remote racking device, the test was initiated remotely by racking the breaker onto the bus (see Fig. 16). The arc fault occurred several seconds into the test when the breaker stabs made contact with the energized line side stabs. Because of the racking device position no calorimeters were placed in front of the circuit breaker compartment.

Fig. 16. Remote racking device used for line side fault of main circuit breaker.

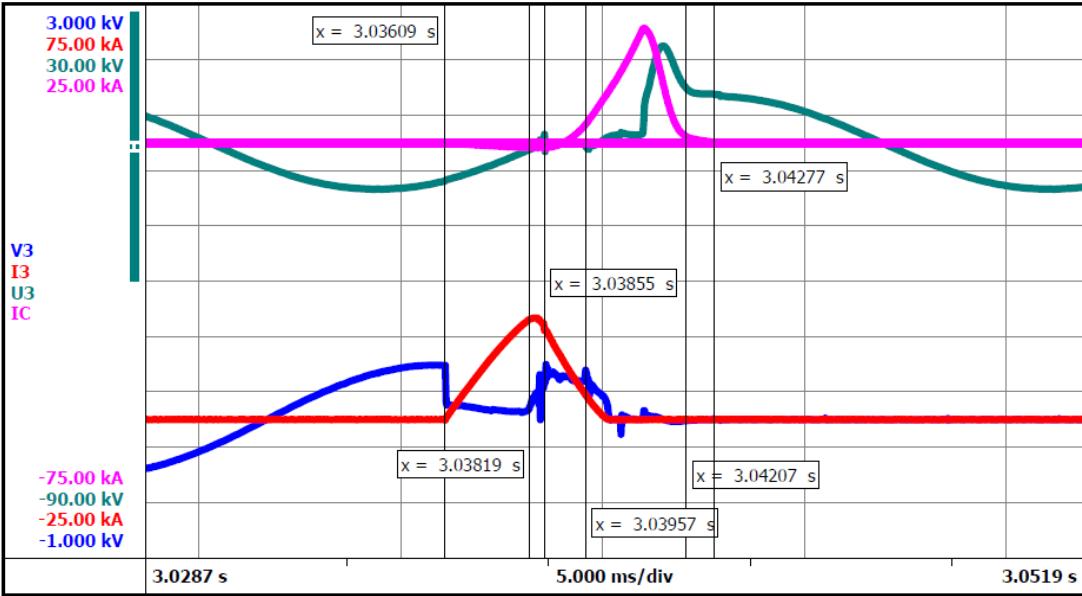
The traces in Fig. 17 show the performance of the system. Performance of the system was very similar to test 5. The secondary currents were limited to the values shown in the summary table. Voltage is near 0V for 2.6 ms. The instantaneous primary current, after HSGS operation, is limited to 23.2kA when the primary fuses melt. The peak value of 23.3kV is well below the limits of IEEE C37.46. Unfortunately, instrumentation for the  $V_{an}$  channel was lost during the test. This prevented the calculation of the arc energy on the secondary system. However, the measured energy on the primary was more than 40% lower than test 5.

Fig. 17. Test 7 waveforms showing operation of system. The low voltage traces are on the bottom

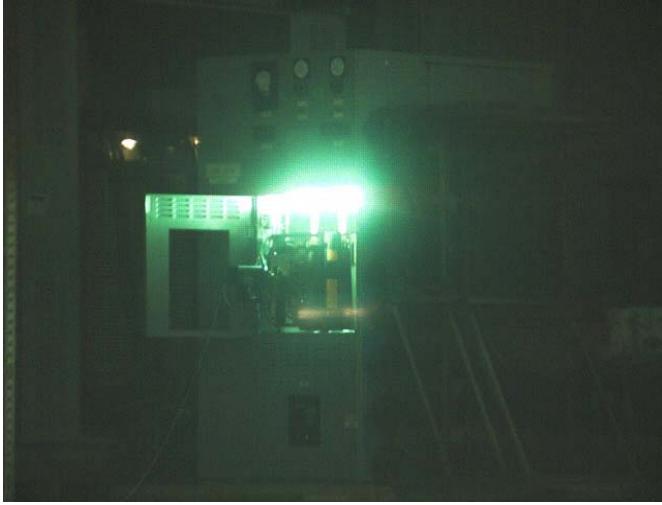
Frames from the high speed video were reviewed. The photo in Fig. 18 shows the farthest reach of the hot gases generated from the arc. As evidenced from the photo of Fig. 19, minimal damage was sustained by the equipment.

Fig. 18. Line side fault with HSGS protection

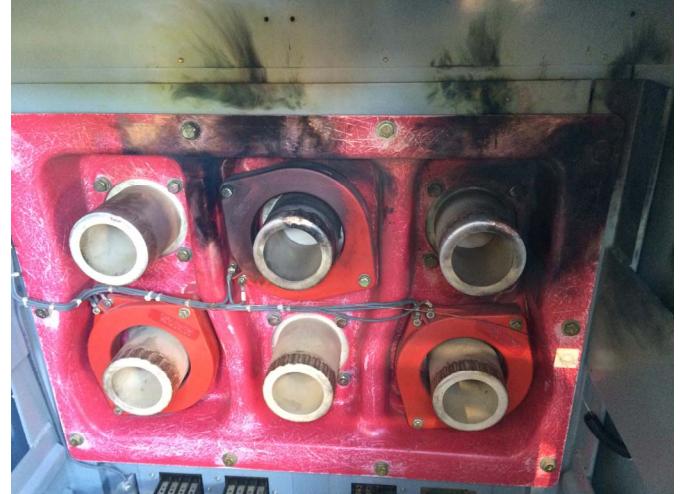
Fig. 19. Damage to Main Compartment after Test 7
