## **Total control over paperboard production in Skoghall**

ABB Web Imaging System (WIS) enables Stora Enso to improve quality and reduce rejects

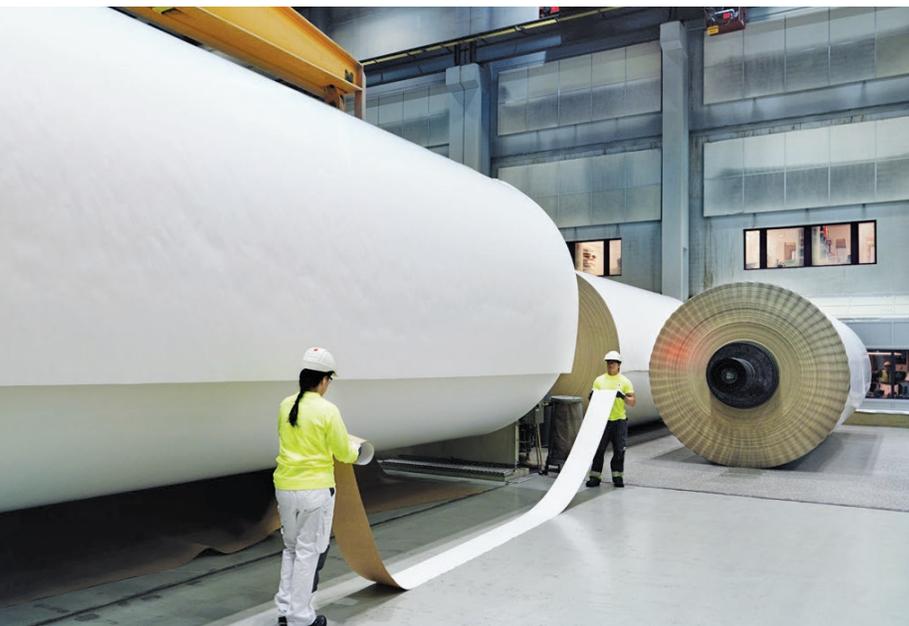
—  
A finished paperboard roll in BM8 weighs 55 metric tons, is approx. 35 kilometers long, and is approx. 8.6 meters wide.
