## **Stanilite®**

## Beware of imitations

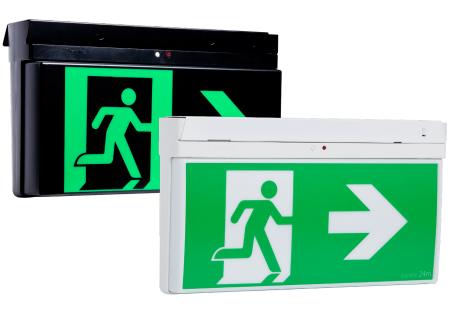
01 LED platinum Quickfit theatre mask single sided picto> exit and LED Platinum Quickfit pictograph exit Whilst rarely called into use, emergency and evacuation lighting is a like the lifeboat on a ship – when the chips are down you'll be hoping you've got the best available because your life may depend upon it. Efficient design, emergency classification and an unsurpassed reputation for reliability are Stanilite hallmarks.

Stanilite's Quickfit® exit range has been expanded to include the latest LED offering which, thanks to the elegant simplicity of its mounting, is easily installed into existing Quickfit brackets. The release of the LED Quickfit exit provides a timely reminder that, whilst imitation may be the sincerest form of flattery, there's nothing quite like the real thing.
